Oil Jet screw plugs on left and right engine case**Affected models: 950 Adventure and Adventure “S” MY 2005**

30/05/008/US_E

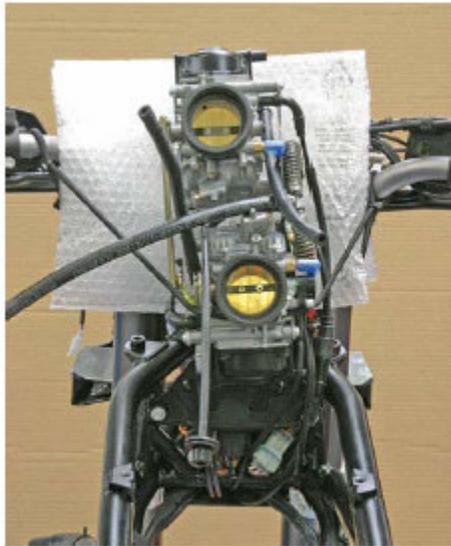
Fig. A

- Air box cover
 - Carburetor trumpets
 - Air filter
 - Remove the carburetors and fix them to the handlebar by using a flexible cord and a protective layer. See fig **A**

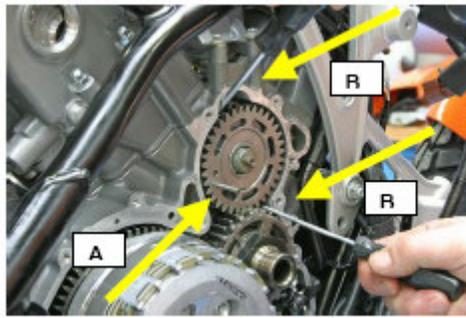
fig. B

- Insert pin into scissor gear (fig. **B**, arrow **A**)
- Remove the nut (M22x 1,5) from the multi shaft
- Remove scissors gear by means of 2 screw drivers (fig. **B** arrows **B**)

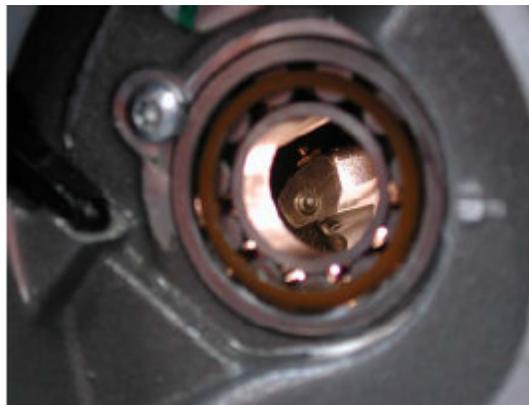
fig. C

- You can now rotate the multi shaft where as the balancer weight can be removed past the primary gear. Remove the woodruff key.
 - Leave the cam chains attached to the 32T intermediate gears.
 - Pull the lower cam chain gear from the clutch side of the multi shaft and remove the woodruff key and bearing support ring
 - Remove the multi shaft from the generator side by tapping lightly with a soft hammer
- » Secure screw plugs on both engine cases
- Remove the crankshaft locking screw and turn the crankshaft to enable access to the oil jets located between the engine cases
 - Illuminate the engine case through the bearing of the multishaft (fig. C)

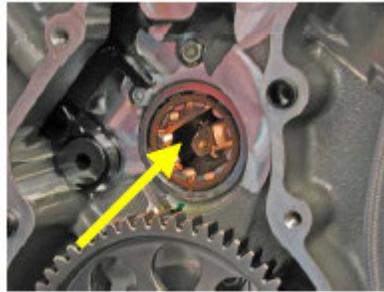
fig. D

- The screw plugs must be between 0.5mm and 1.0mm below the surface of the engine case. (Fig **D** and **E**)

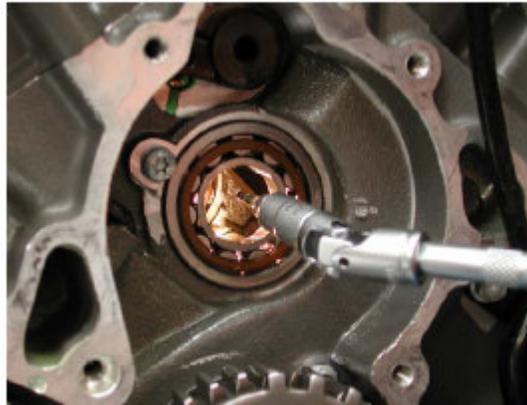
fig. F

- Screw both oil jet plugs with supplied 2.5mm Allen key through the multi shaft bearing bores. (Fig **F**)

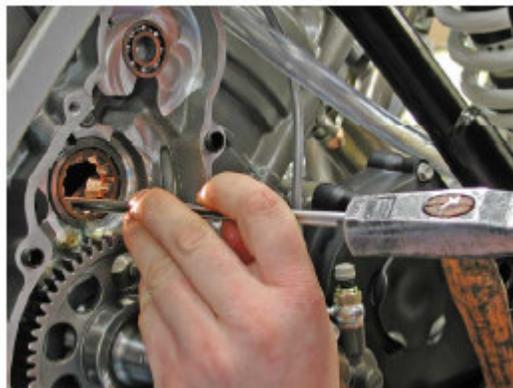
fig. G

- Insert the special punch from the left and right side multi-shaft bearing bores and dot punch each case so that the screw becomes secured. (Fig **G** and **H**)

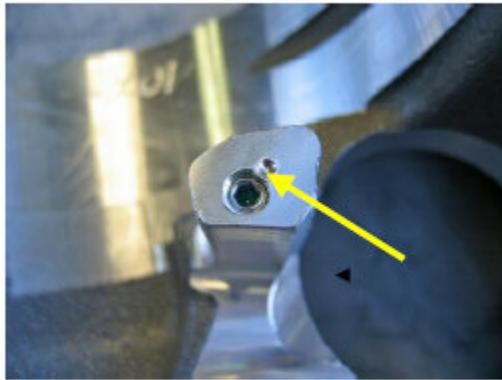
fig. H

- **CAUTION:** The position and dimension of the punches have to be as shown in Fig **H**

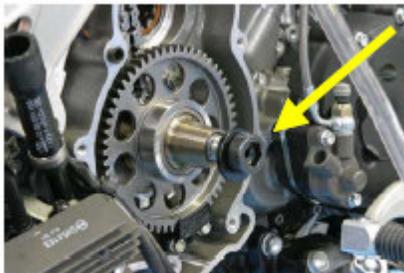
fig. L

- Special tools as shown in Fig **J** will be supplied automatically and free of charge
- » To verify that the oil jets are clear and passages are clear, please test with compressed air:
- Block the crankshaft on the generator side with ignition rotor mounting bolt. Fig **L**

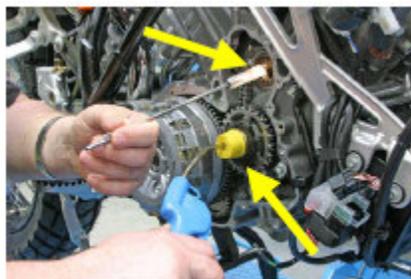
fig. M

- Fit supplied plastic cap to crankshaft on the clutch side and inject air. Fig **M**

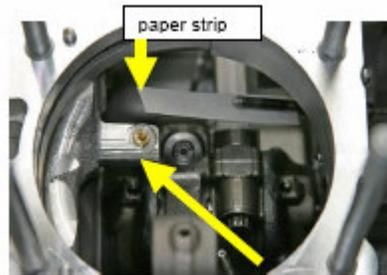
fig. N

- At the oil jet of the left case, airflow must be noticed. If there are any doubts please check with paper strip **Fig N**

- Attention: **Fig N** only demonstrates the procedure and the positions as they are not visible with the top ends installed
- Plug oil bore at the front cylinder head with plastic cap and block timing chain tensioner. **Fig O**

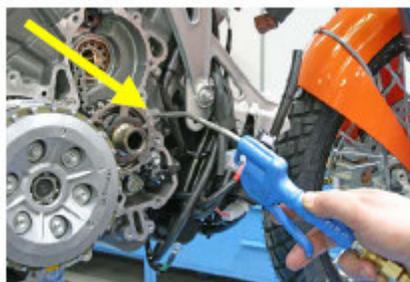
fig. P

- Inject air into the oil bore of the right engine case **Fig P**

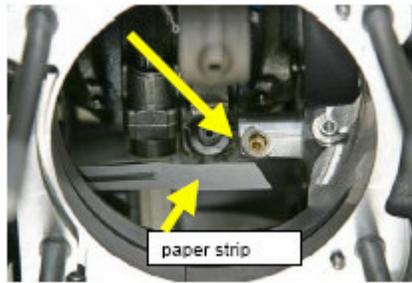
fig. Q

- At the oil jet of the right case, airflow must be noticed. If there are any doubts please check with paper strip **Fig Q**
